# CASE SERIES

## *Brett Wiater, MD Performs Stemless TSA On Paramedic With Humeral Deformities*

### Implant

Catalyst CSR cemented humeral  
component; 3-Peg Glenoid component

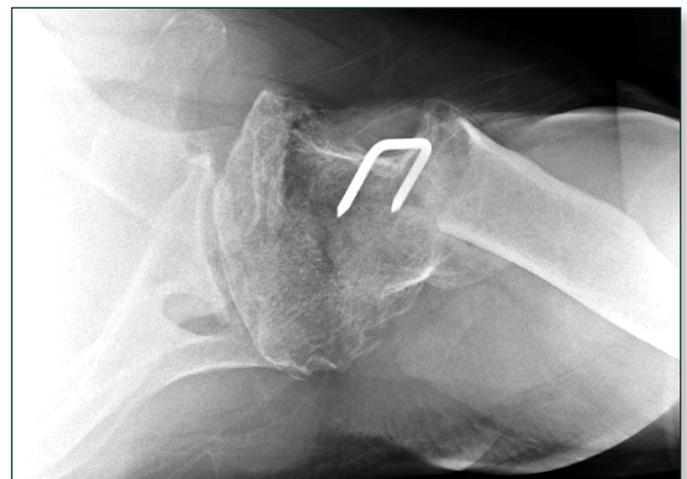
*Preoperative images*

The patient presented with osteoarthritis with a flattened humeral head. His Walch B3 glenoid was significantly eroded, with approximately 25° of retroversion.

His preoperative range-of-motion scores were 60° of forward extension (FE), 15° of external rotation (ER), internal rotation (IR) to the belt line, and abduction of 40°.

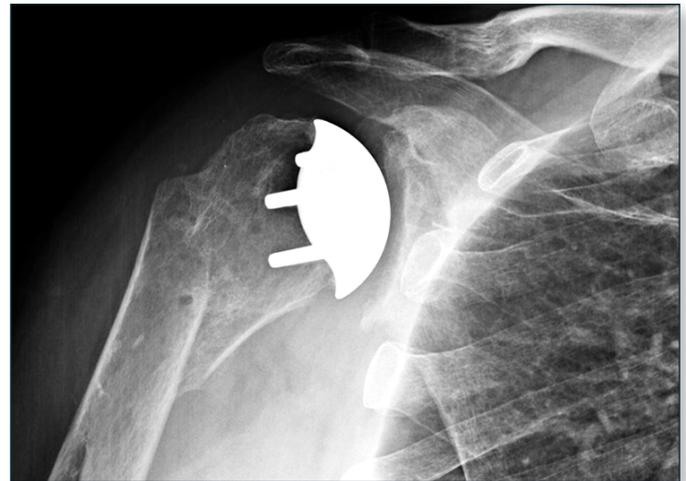
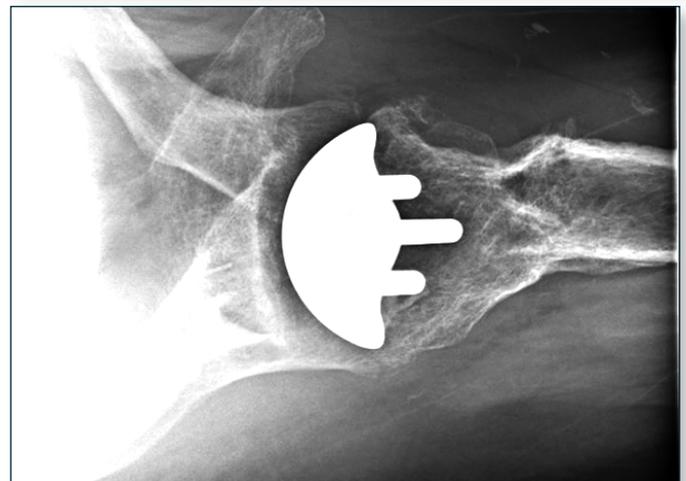
Post operative images

Dr. Wiater performed a TSA using the Catalyst CSR™ Total Shoulder System. He used a tenotomy for the subscapularis repair.

Due to the very large humeral deformity, Dr. Wiater believed the Catalyst CSR system was the best option for this case due to the stemless humeral component and the bone-sparing multiplanar osteotomy technique.

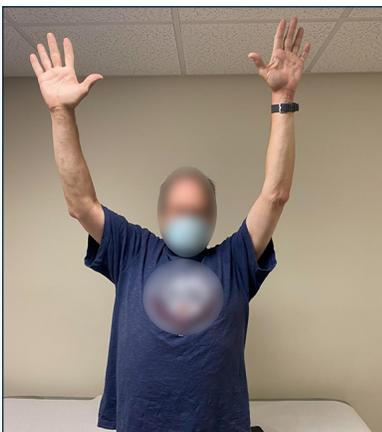
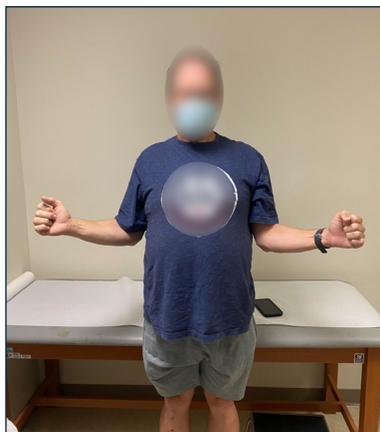
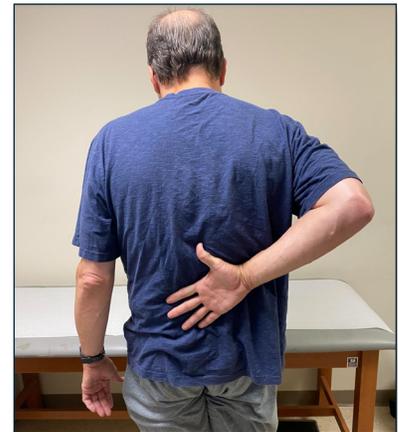
## Patient At Three Months Post Op

At his three-month post op follow up, the patient’s range-of-motion scores were significantly improved, with 140° of FE, 45° of ER, and internal rotation (IR) to T12.

The patient has done extremely well and returned back to work as a paramedic three months post operatively.
